Myler Ecological Consulting

RE: Environmental Impact Study Memorandum – 694 & 698 Niagara Street, Welland

Introduction

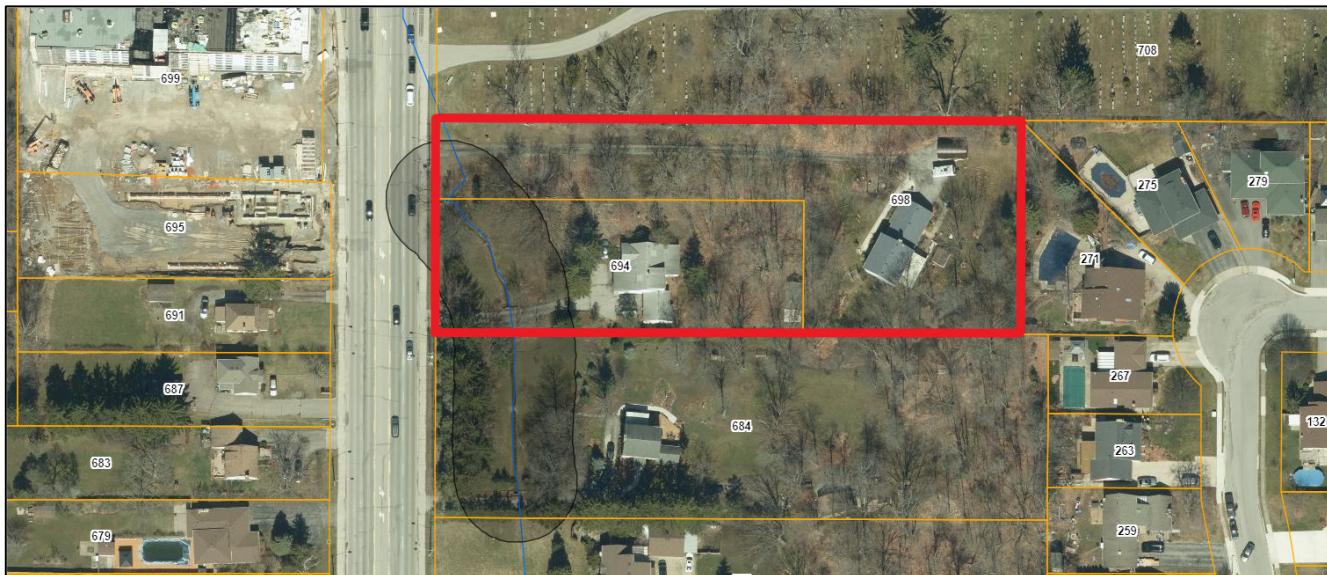
Figure 1: Excerpt of NPCA Watershed Explorer mapping showing the site (red outline) and the NPCA-regulated watercourse (blue line) and regulation area (dark shading) near Niagara Street.

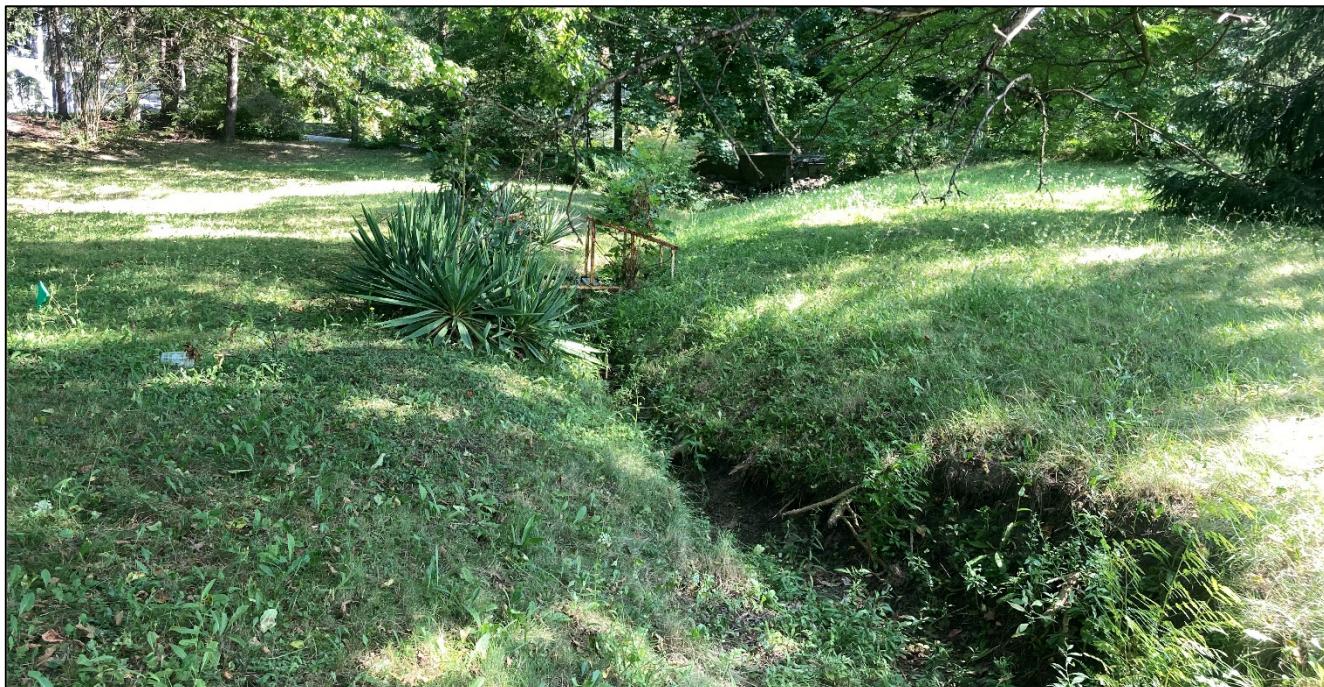
The portion of the site containing the watercourse, and the watercourse channel itself, were yet again confirmed by Myler's observations to be in a manicured condition consistent with the existing residential use of the site and therefore not possessed of any natural vegetation community described by the provincial Ecological Land Classification (ELC). The watercourse segment traverses a mown front yard turfgrass area with planted amenity trees, shrubs and plants plus a typical assortment of weed species (see **Photos 1** and **2**, below).

Photo 1: Watercourse segment on site, facing upstream. Note manicured lawn, planted Yucca, weeds, and dry channel with terrestrial plants.

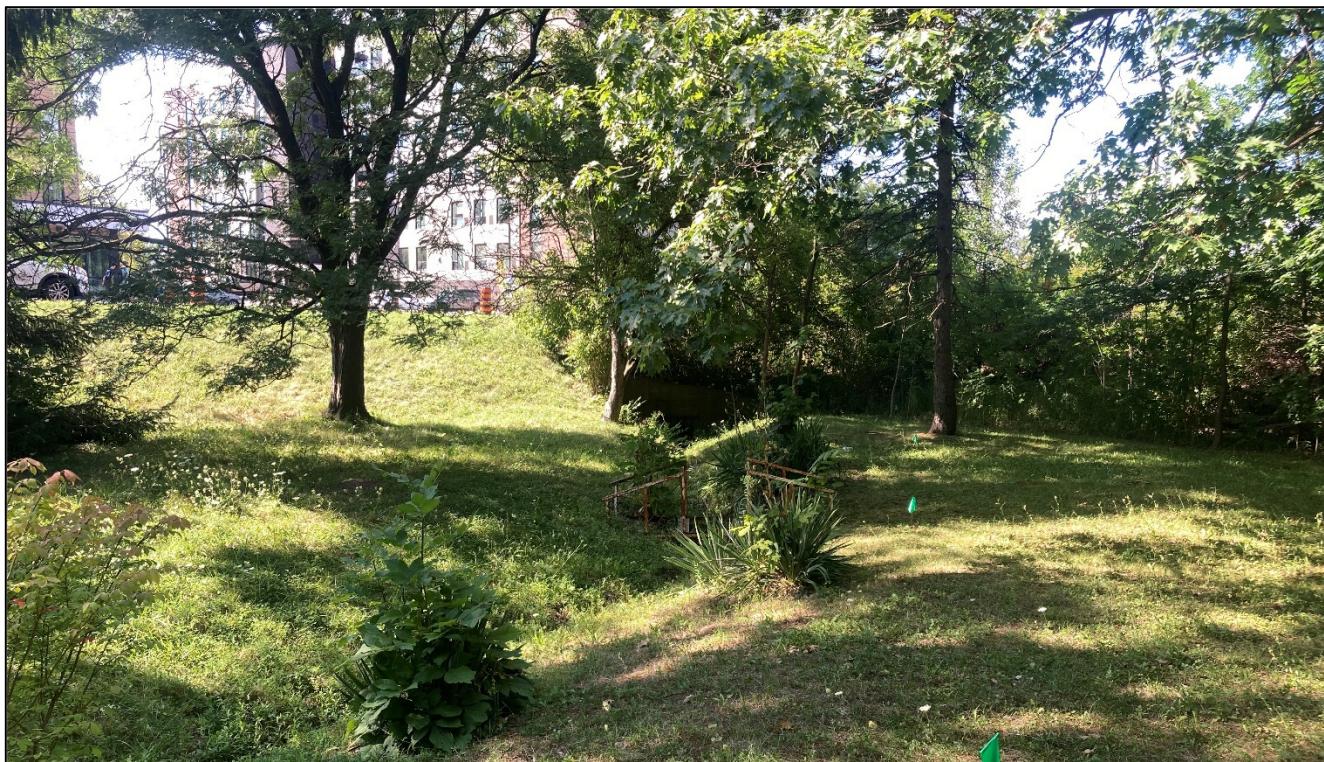
Photo 2: Watercourse segment facing downstream towards storm sewer catch basin (in shadow in background beneath shrubs and trees). Note topography and depth below Niagara Street in background. Myler's observations confirmed a lack of aquatic or riparian habitat and associated wildlife that might otherwise trigger recommendations for specialized mitigation measures such as salvage of fish, amphibians and reptiles.

Only a general mitigation measure is recommended for removal of trees and shrubs at and near the watercourse segment and throughout the site to avoid potential impacts to nesting birds and roosting bats. Tree and shrub removal during the October-March period will achieve seasonal avoidance of the local bird nesting season and the active roost period of Ontario bats.
