# Myler Ecological Consulting

17 December, 2025

**RE: Environmental Impact Study Memorandum – 694 & 698 Niagara Street, Welland**

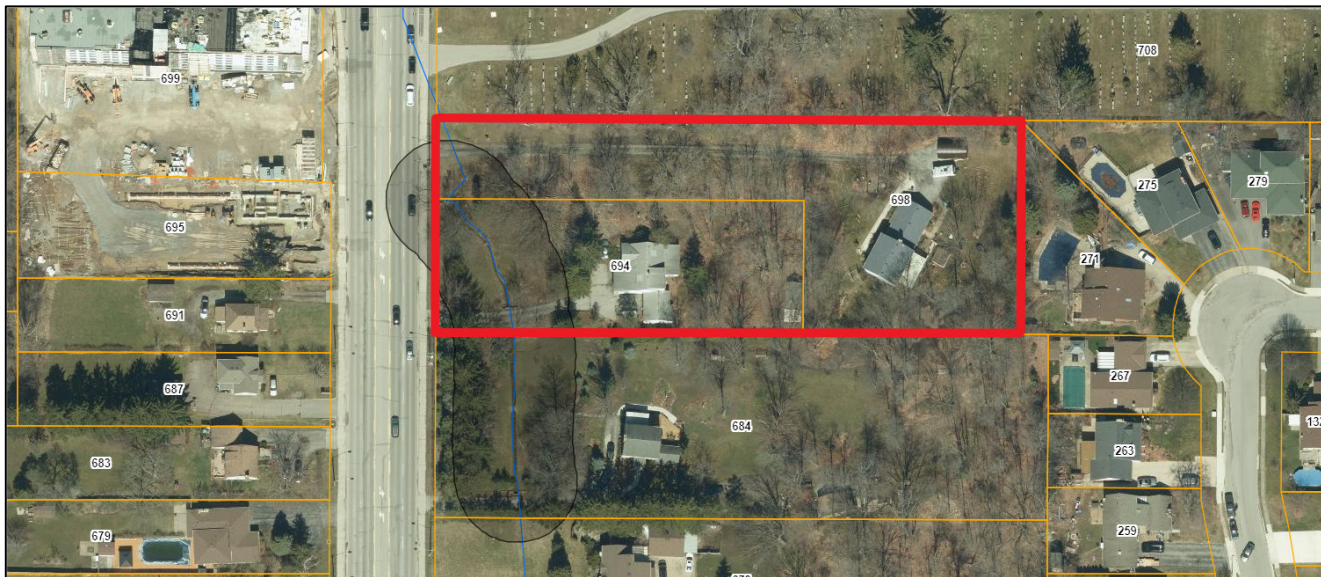
**Figure 1:** Excerpt of NPCA Watershed Explorer mapping showing the site (red outline) and the NPCA-regulated watercourse (blue line) and regulation area (dark shading) near Niagara Street.

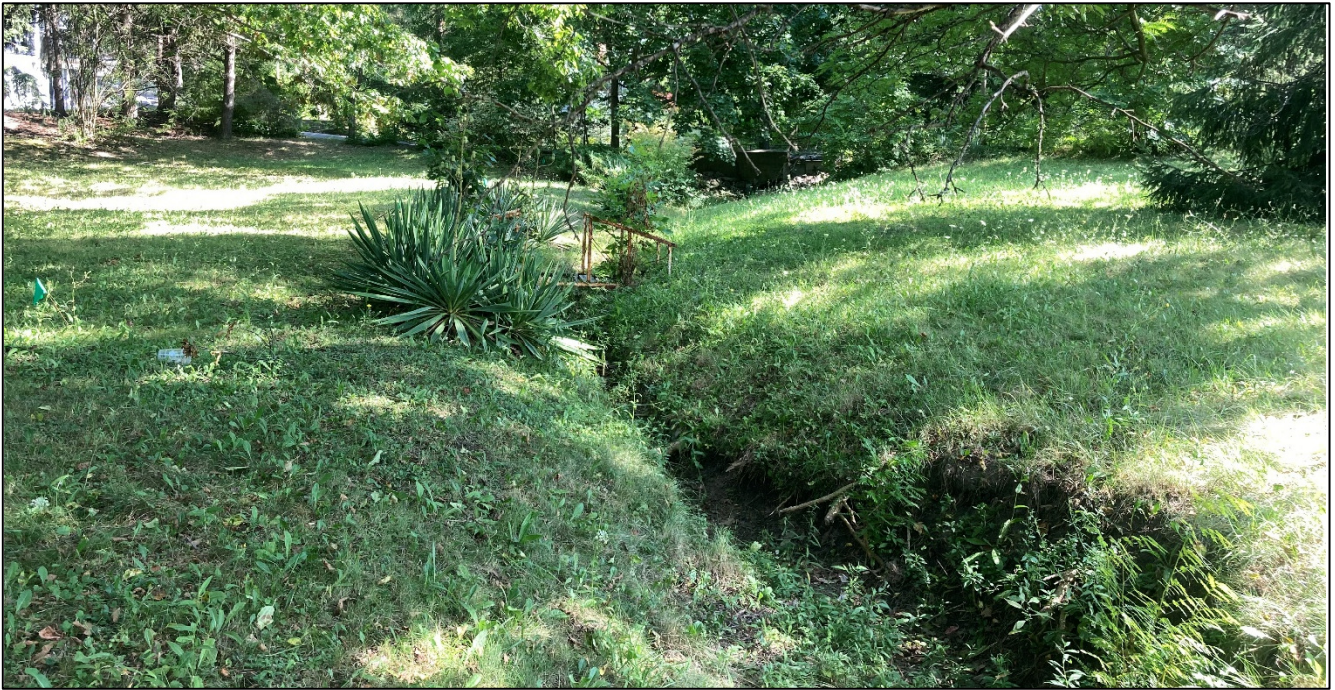
The portion of the site containing the watercourse, and the watercourse channel itself, were yet again confirmed by Myler's observations to be in a manicured condition consistent with the existing residential use of the site and therefore not possessed of any natural vegetation community described by the provincial Ecological Land Classification (ELC). The watercourse segment traverses a mown front yard turfgrass area with planted amenity trees, shrubs and plants plus a typical assortment of weed species (see **Photos 1** and **2**, below).

**Photo 1:** Watercourse segment on site, facing upstream. Note manicured lawn, planted Yucca, weeds, and dry channel with terrestrial plants.

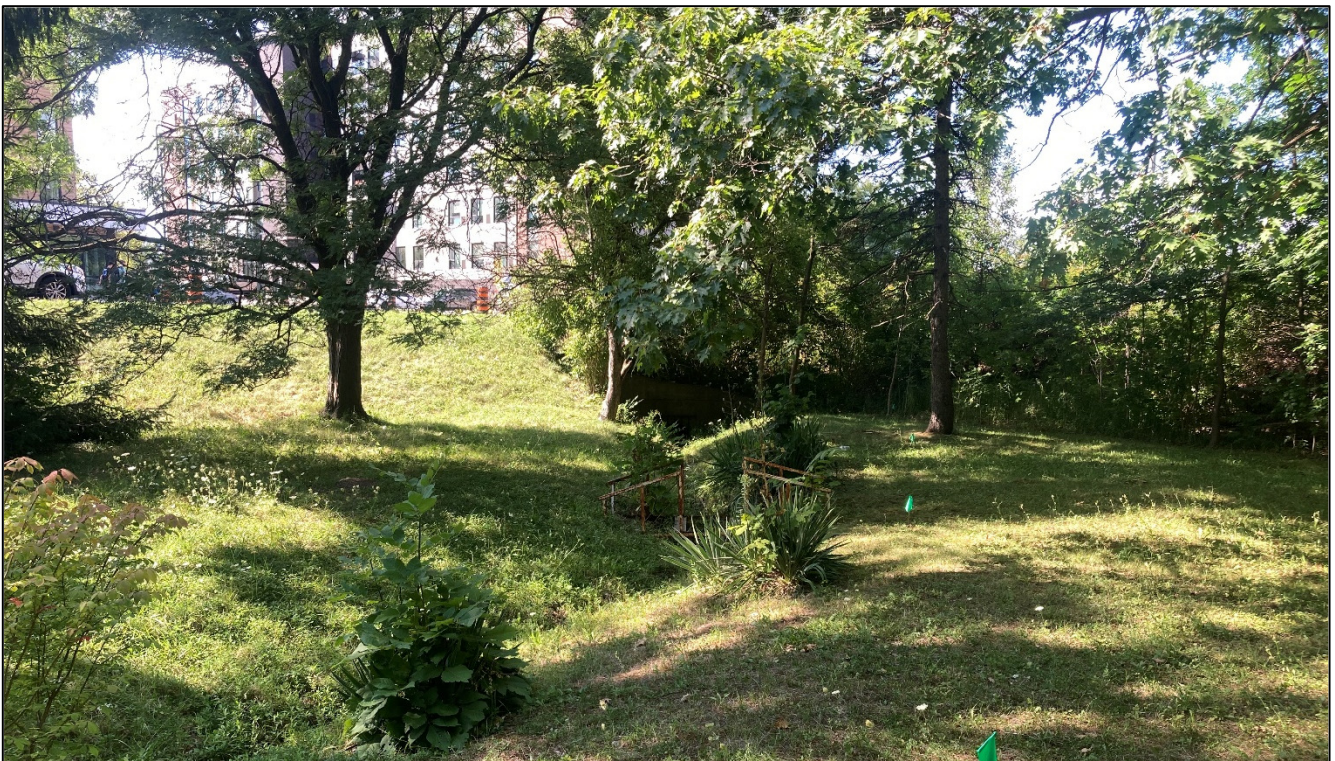
**Photo 2:** Watercourse segment facing downstream towards storm sewer catch basin (in shadow in background beneath shrubs and trees). Note topography and depth below Niagara Street in background. Myler's observations confirmed a lack of aquatic or riparian habitat and associated wildlife that might otherwise trigger recommendations for specialized mitigation measures such as salvage of fish, amphibians and reptiles.

Only a general mitigation measure is recommended for removal of trees and shrubs at and near the watercourse segment and throughout the site to avoid potential impacts to nesting birds and roosting bats. Tree and shrub removal during the October-March period will achieve seasonal avoidance of the local bird nesting season and the active roost period of Ontario bats.
