Public Works

2019 Fleet Enterprise & Water / Sewer Capital Budget Requirements

Prepared by: Adam Beres – Manager of Fleet, Equipment and Purchasing
Date: October 2018

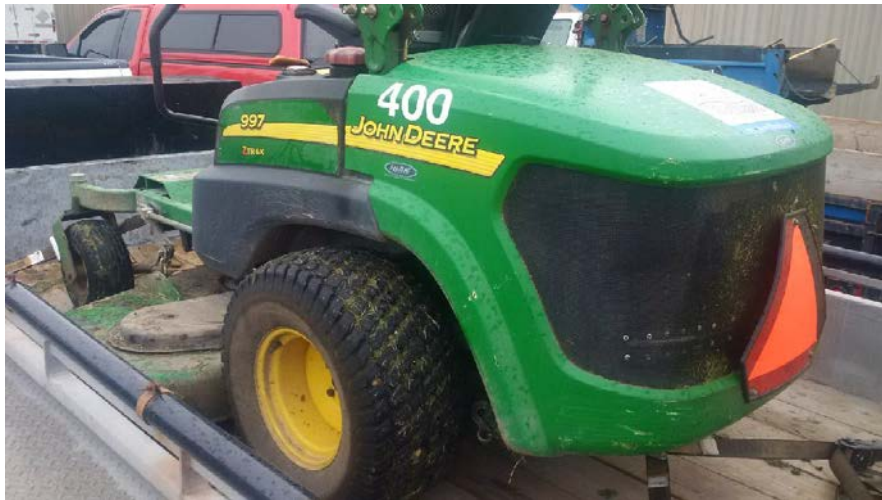
ASSET to be replaced: Unit 400, 2009 John Deere Zero Turn Mower

- 2009 Purchase Price: \$15,469.00 + GST & PST
- 2019 Budgeted Replacement Cost: \$24,500 HST Inclusive
- Hours: 3439
- Repair Costs – Parts and labour (2009 – 2018) \$11,974
- Unit has high hours, is exhibiting rust and scheduled for replacement

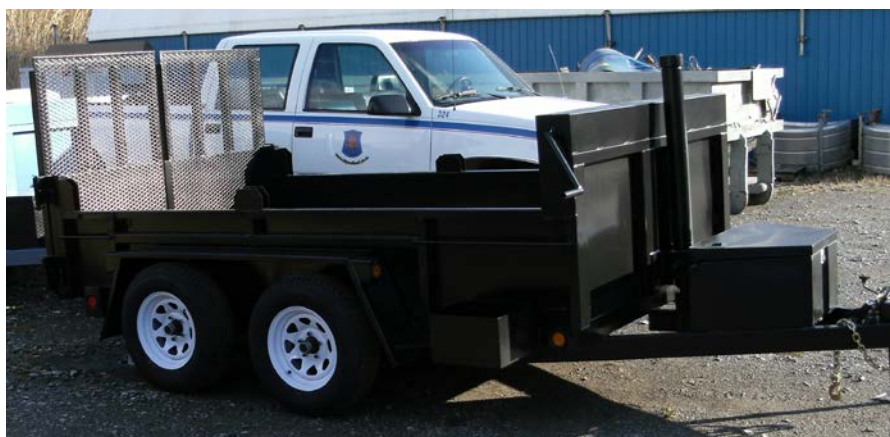
ASSET to be replaced: Unit 348-8 2001 Tandem dump trailer

- Purchase Price: \$5,640 + GST & PST
- 2019 Budgeted Replacement Cost: \$8040.00 HST Inclusive
- Unit is scheduled for replacement

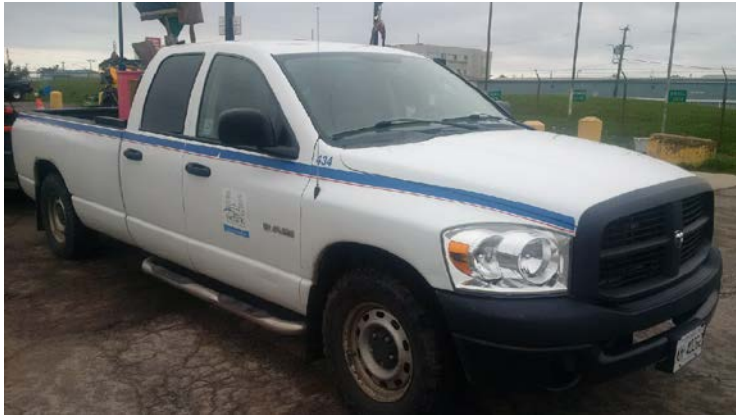
ASSET to be replaced: Unit 434, 2008 Dodge Ram Crew Cab Pickup

- 2008 Purchase Price: \$23,887+ GST & PST
- 2019 Budgeted Replacement Cost: \$35,560 HST Inclusive
- Mileage: 119,000km
- Repair Costs – Parts and labour (2008 – 2018) \$14,709
- Unit scheduled for replacement. Underbody rust is apparent.

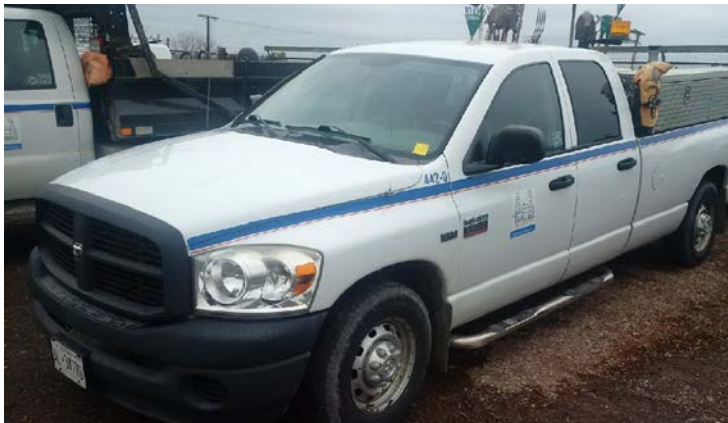
ASSET to be replaced: Unit 442, 2009 Dodge Ram Crew Pickup

- 2009 Purchase Price: \$26,295+ GST & PST
- 2019 Budgeted Replacement Cost: \$38,850 HST Inclusive
- Mileage: 81,870km
- Repair Costs – Parts and labour (2009 – 2018) \$19,626
- Unit scheduled for replacement. Replacement vehicle will have $\frac{3}{4}$ ton capacity instead of current $\frac{1}{2}$ ton.

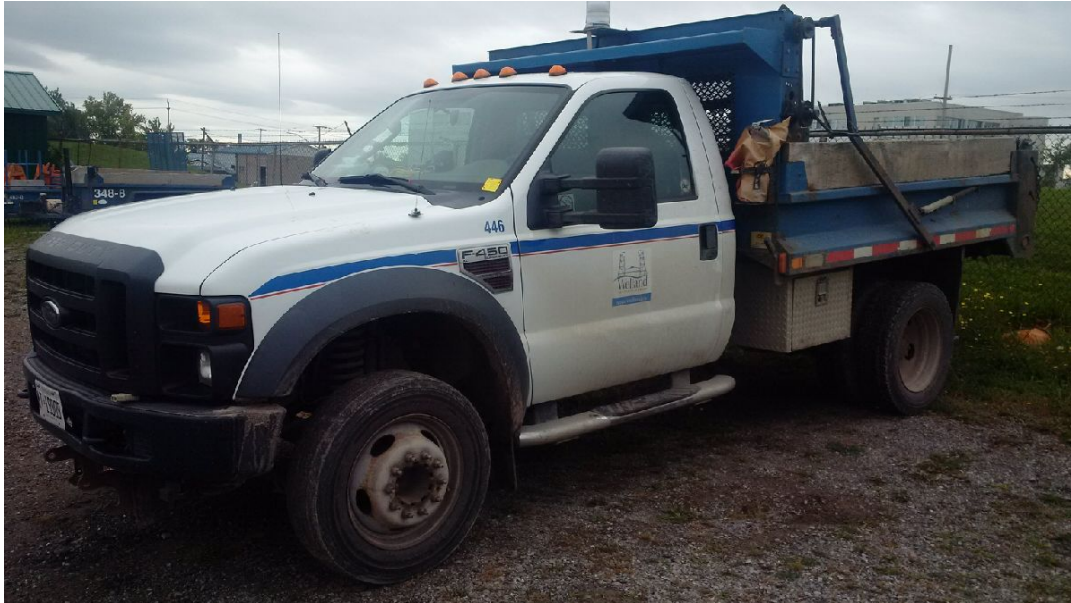
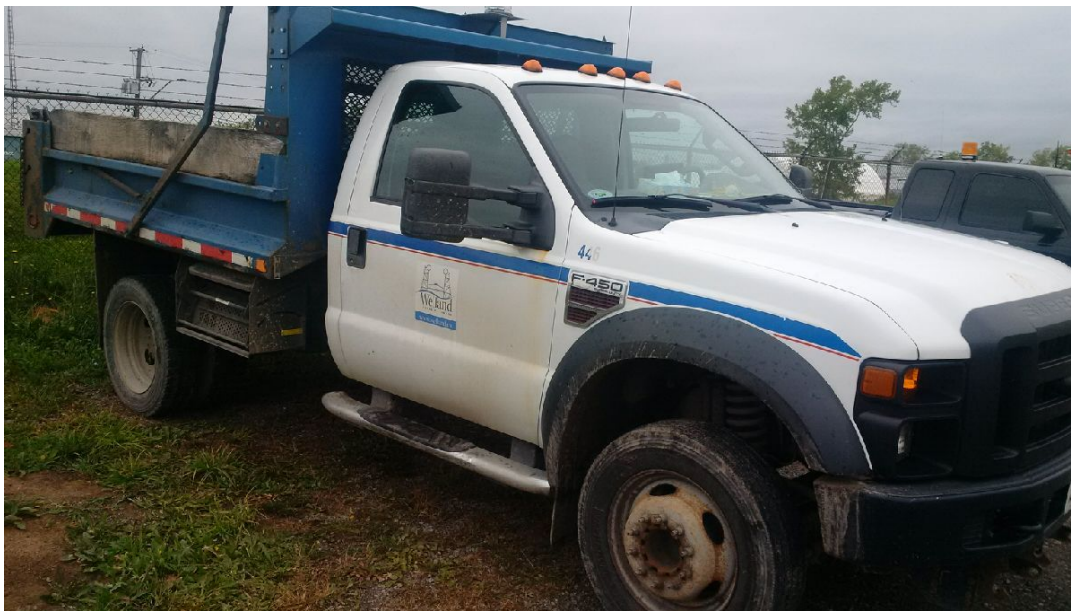
ASSET to be replaced: Unit 446, 2009 Ford F450 Super Duty with plow

- 2008 Purchase Price: \$46,799+ GST & PST
- 2019 Budgeted Replacement Cost: \$67,700 HST Inclusive
- Mileage: 215,456km
- Hours: 1064
- Repair Costs – Parts and labour (2008 – 2018) \$33,650
- Unit has high mileage and is scheduled for replacement.

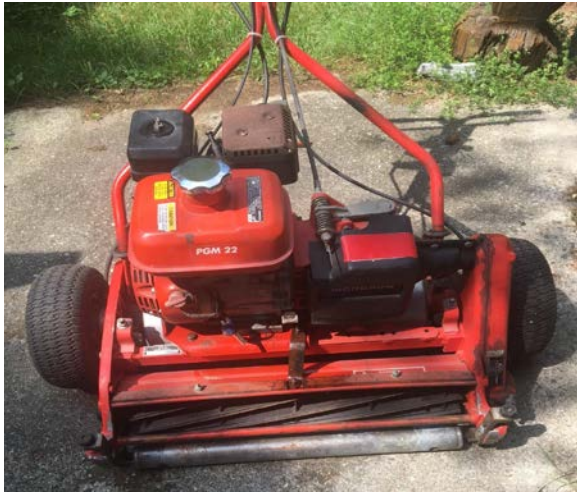
ASSET to be replaced: Unit 370, 2001 Jacobsen PGM Greens Mower

- 2001 Purchase Price: \$6,895 + GST & PST
- 2019 Budgeted Replacement Cost: \$10,300 HST Inclusive
- Repair Costs – Parts and labour (2001 – 2018) \$7,091
- Unit is well used, and scheduled for replacement
-

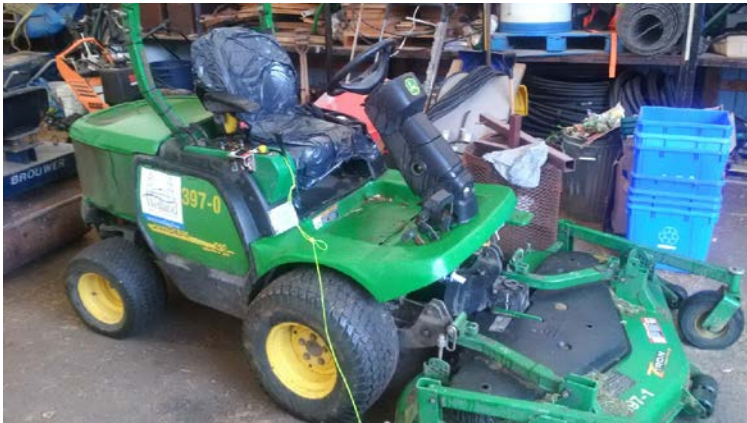
ASSET to be replaced: Unit 397, 2008 John Deere front mount mower with cab, mower, broom and snow blower attachments

- 2008 Purchase Price: \$36,132 + GST & PST with attachments
- 2019 Budgeted Replacement Cost: \$45,500 HST Inclusive
- Hours: 4,100
- Repair Costs – Parts and labour (2008 – 2018) \$25,500
- In addition to high hours, rust is developing on floor and foot rests.

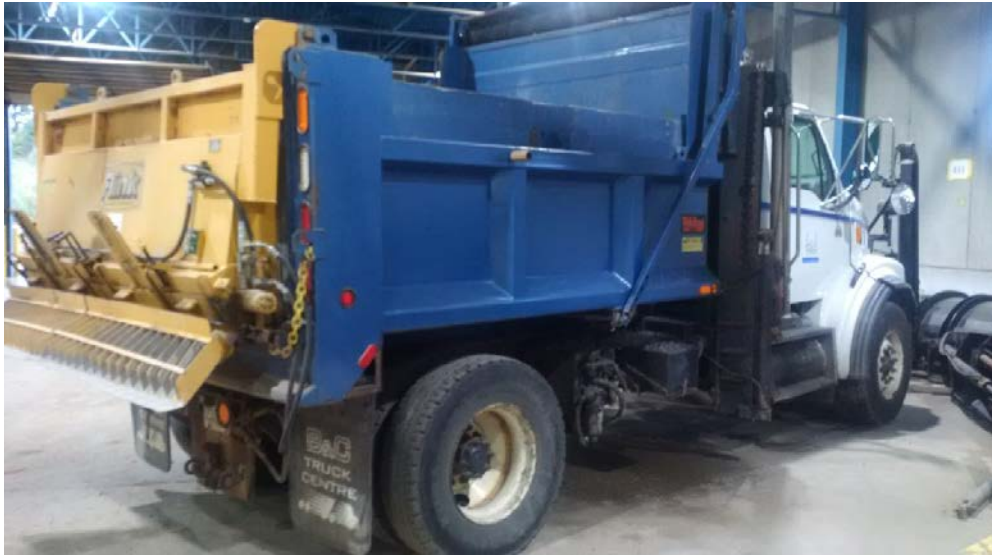
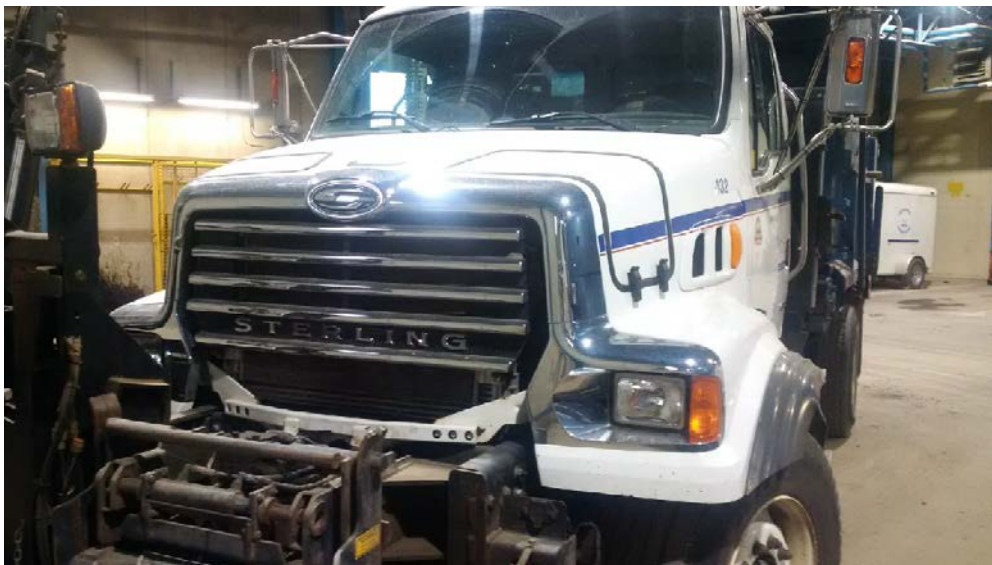
ASSET to be replaced: **Unit 432**, 2008 Sterling dump truck with plow and wing, sanding box and anti-ice system

- Years In Service: 10
- 2008 Purchase Price: \$198,778 + GST & PST
- 2019 Budgeted Replacement Cost: \$315,000 HST Inclusive
- Hours: 4471
- Mileage: 113,919km
- Repair Costs – Parts and labour (2008 – 2018) \$90,833
- Unit is well used especially for snow clearing operations, thus high hours and need for replacement. Prolonging replacement may risk mid-season failure.

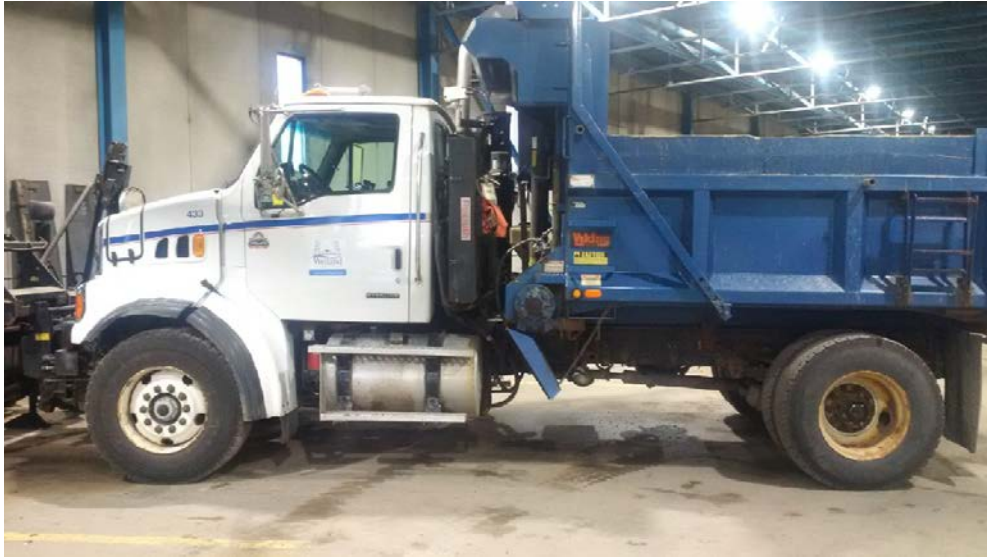
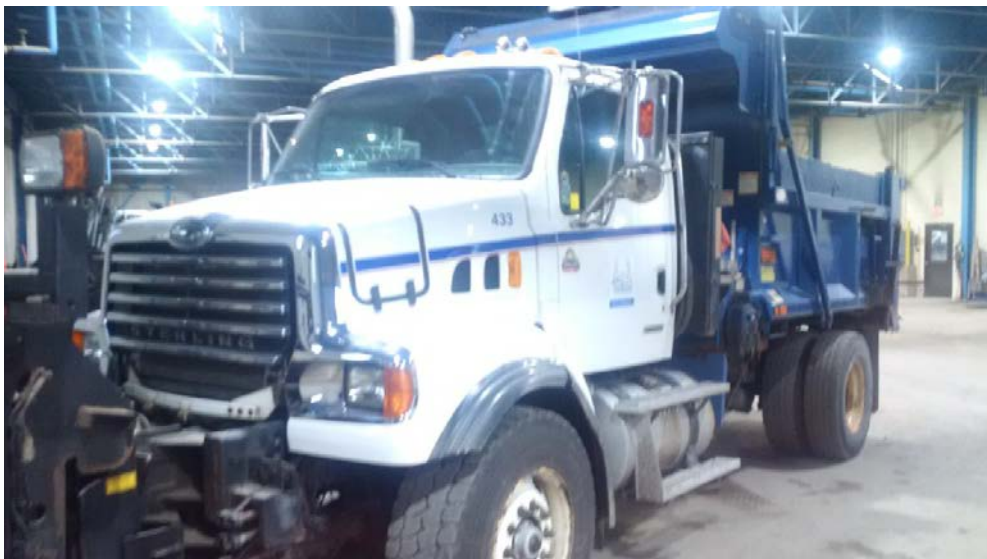
ASSET to be replaced: **Unit 433**, 2008 Sterling dump truck with plow and wing, sanding box and anti-ice system

- Years In Service: 10
- 2008 Purchase Price: \$197,98 + GST & PST
- 2019 Budgeted Replacement Cost: \$315,000 HST Inclusive
- Hours: 6072
- Mileage: 100,201km
- Repair Costs – Parts and labour (2008 – 2018) \$78,028
- Unit is well used especially for snow clearing operations, thus high hours and need for replacement. Prolonging replacement may risk mid-season failure.

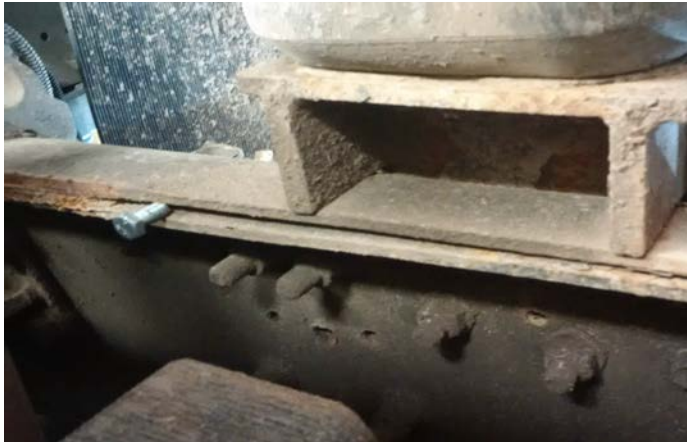
ASSET requiring work: Unit 459, 2008 Sterling dump truck frame repair

- Frame for this plow truck requires complete replacement due to rust jacking, a condition where the gap between inner and outer frame rail exceeds 10mm. When this dimension is exceeded, the frame will no longer pass MTO inspection. Staff recommend replacing the frame as a cost-containment effort, as the remaining vehicle is in usable condition.
- 2019 Budgeted Replacement Cost: \$51,000 HST Inclusive

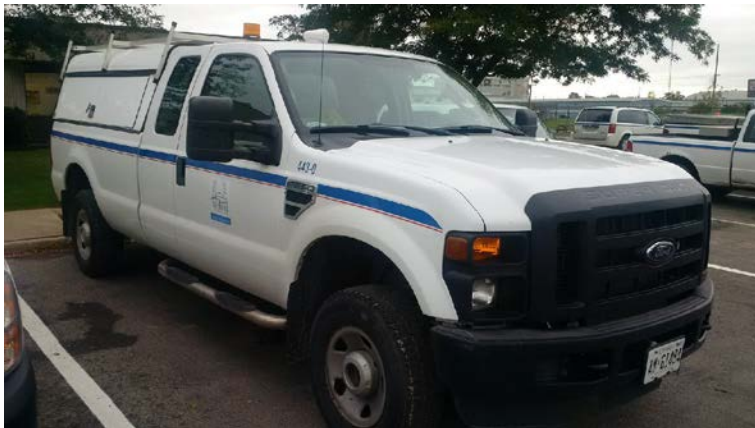
ASSET to be replaced: Unit 443, 2009 Ford Pickup with plow: On Call vehicle

- 2009 Purchase Price: \$28,956 + GST & PST
- 2019 Budgeted Replacement Cost: \$35,500 HST Inclusive
- Mileage: 187,000km
- Repair Costs – Parts and labour (2009 – 2018) \$38,005
- Unit scheduled for replacement. Unit is well used, thus higher mileage.

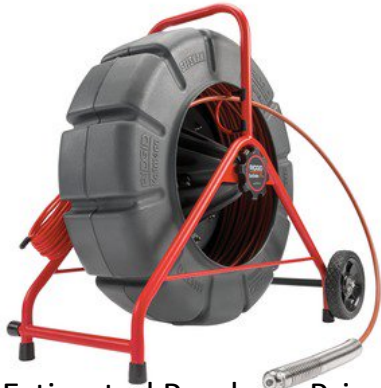
Proposed style, or similar

New Asset: CCTV Video Inspection Unit with reel, digital recording unit.

- Estimated Purchase Price: \$25,000 HST Inclusive
- Equipment Purpose: Unit is used for sewer inspections and helps determine location and nature of blockage.

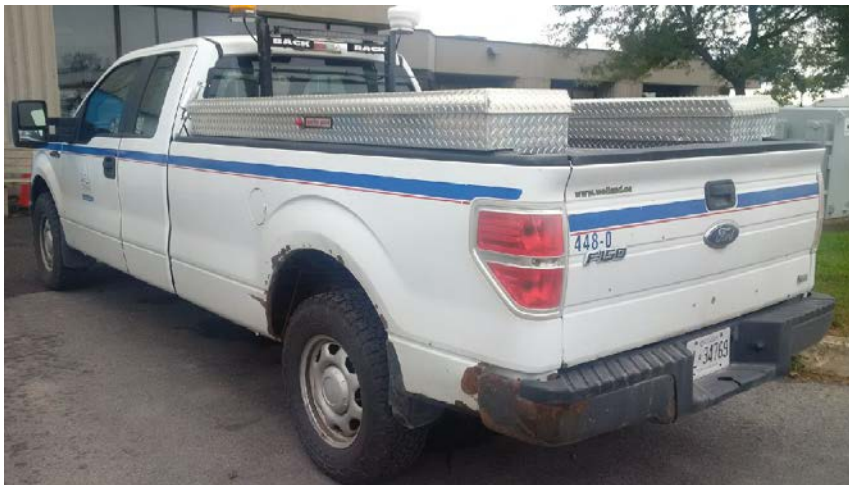
ASSET to be replaced: **Unit 448**, 2010 Ford Pickup

- 2008 Purchase Price: \$24,011 + GST & PST
- 2019 Budgeted Replacement Cost: \$33,500 HST Inclusive
- Mileage: 145,500 Hours: 7827
- Repair Costs – Parts and labour (2009 – 2018) \$24,805
- Unit scheduled for replacement. Rust is developing and becoming extensive towards rear of unit.
